Manhole Inspection Summary

Manhole # S37II_024MH

Location Address: **424 PITTMAN PL**

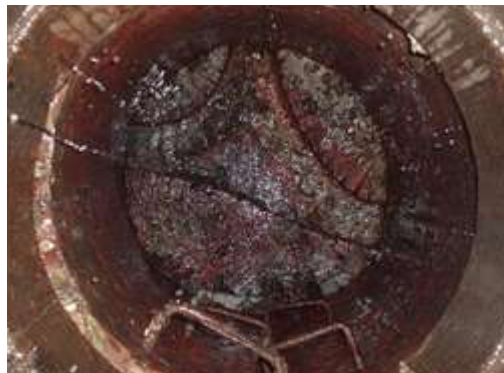
Top View

Corroded steps. Evidence of surcharge - Bench debris.

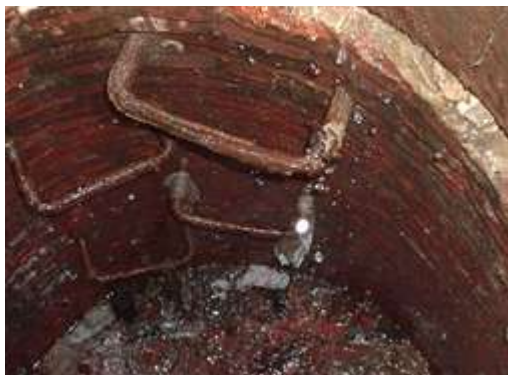
Defect

corroded steps and surcharge evidence

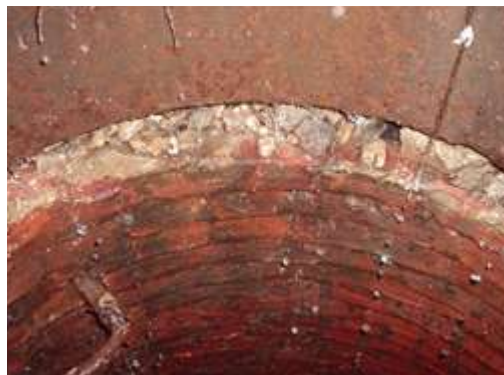
Defect

Frame leaks. Adjustment deterioration and infiltration. Cobel infiltration - other side.

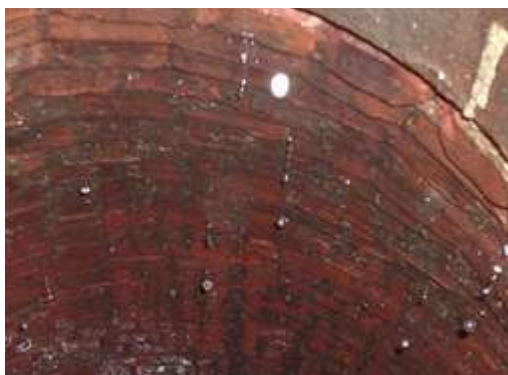
Defect

Frame leaks. Adjustment deterioration and infiltration. Cobel infiltration.

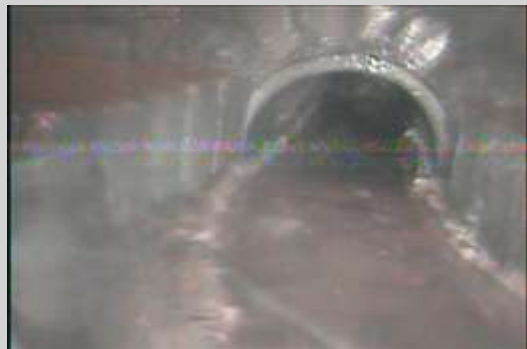
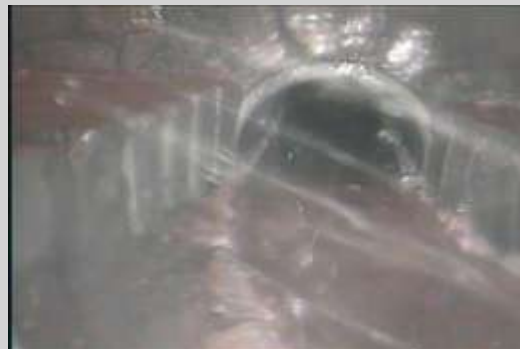
Pipe In @ 9 O'Clock

Deposits: ☐ None ☐ Mud ☐ Sludge ☐ Debris ☒ **Grease**

Deposits Extent: **Light**
